Mineral Compositions and Micro-Structural of Epoxy-Repaired Rock Revealed by X-ray Diffraction and Scanning Electron Microscopy

Keywords: Epoxy-repaired rock, microstructural, mineral compositions, scanning electron microscopy, X-ray diffraction

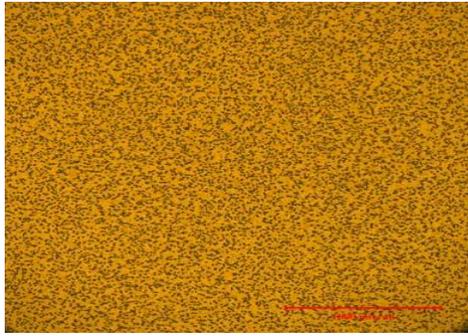
Fig. 1: Polarizing microscope photo of the epoxy resin

Materials: A two component epoxy resin was selected for optimization and several modifications were made to the original composition provided. Figure 1 shows a polarizing microscope photo of the epoxy resin for chemical grouting of faults.

Component A is mixture of epoxy resins, component B is amine-hardener, the gravity ratio of component A and B is 6:1. The final epoxy resin composition adequately fulfilled the project requirements and is now commercially available.

As shown in Fig. 6 (compared with Fig. 1), the cracks and voids in the fractured rock are filled with epoxy resins.

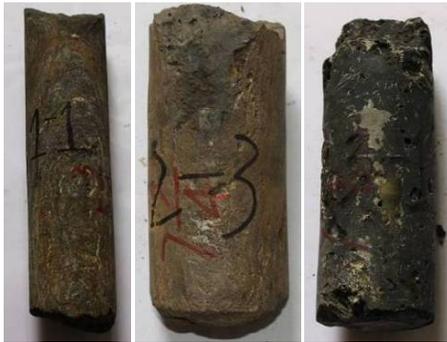
Fig. 2: Epoxy-repaired rocks

After the epoxy resin is completely solidified, the chemical grouting process for rock fault is finished. The epoxy-repaired rock is prepared by borehole drilling. Figure 2 shows the epoxy-repaired rocks in the fault zone.

As shown in Fig. 2, the left one is epoxy-repaired weak weathered green schist, the middle one is epoxy-repaired strongly weathered green schist and the right one is epoxy-repaired carbonaceous green schist.

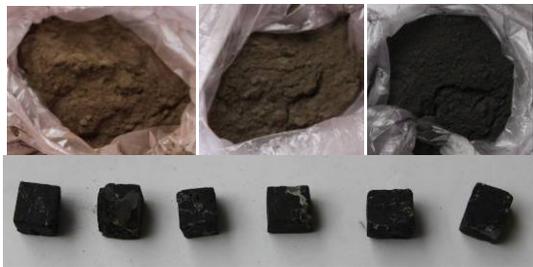
Fig. 3: Sample preparation for XRD and SEM tests

Sample preparation: The epoxy-repaired rock should be pressed into powder for XRD test, the particle diameter is less than 0.001 mm. But the epoxy-repaired rock should be cut and polished into thin slice for SEM test, the length and width are all 1.0 cm, the height should be not larger than the length.

Figure 3 shows the sample preparation for XRD and SEM tests. As shown in Fig. 3, three types of rock powder are corresponding to the different rock type. The left, middle and right ones are rock powder of epoxy-repaired weak weathered green schist, strongly weathered green schist and carbonaceous green schist. There is an obvious difference in rock powder between each rock type. At the lower of Fig. 3, these specimens are thin slice of epoxy-repaired rock for SEM tests. Here we can see the epoxy resin existed in the fractured rocks.

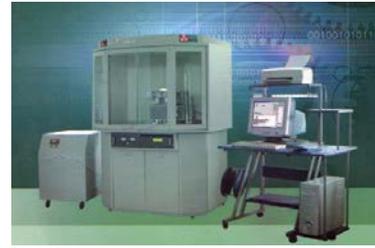
Fig. 4: X-ray diffraction test system

Representative portions of each epoxy-repaired rock were more finely ground in a ring-grinder mill and the particle diameter is less than 0.001 mm. The minerals in each case were identified from the diffractograms by reference to the rock Powder Diffraction File. Figure 4 shows the test system for X-ray diffraction.

X-ray diffraction method: X-ray diffraction (XRD) is an analysis method that uses X-rays to determine the range of physical and chemical characteristics of materials (Ruan and Ward, 2002; Hestnes and Soensen, 2012). This includes analysis for the types and quantities of different phases in the sample. During the semi-quantitative XRD method, the mineral proportions received by sample analysis are compared to known intensity and information found in a database distributed by the International Centre for Diffraction Data.

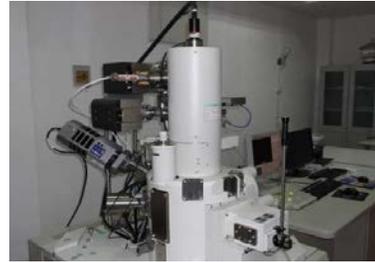
Fig. 5: Scanning electron microscopy test system

Scanning electron microscopy Scanning electron microscopy analyses on extracted micro structural characteristics of epoxy-repaired rock provide the detail morphology and texture of such grains. This is important since anthropogenic magnetic particles can be distinguished from specific morphology. Figure 5 shows the test system for scanning electron microscopy.

Selection criteria for grain analyses by SEM were based on the subjective differences observed in the morphology and texture behaviors. The filling situation of epoxy resins in the fractured rock can be determined by SEM method.

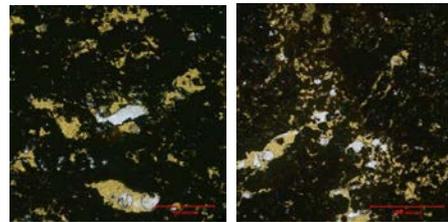
Fig. 6: Polarizing microscope photo of the epoxy-repaired rock sample

As shown in Table 1, the porosity of original fractured rock is about 15%-20%, after the chemical grouting by epoxy resins, some of the cracks and voids are repaired by epoxy particles, resulted in the decreasing rock porosity. Its mean that, the quality of fractured rock is improved by the epoxy resins. Figure 6 shows a polarizing microscope photo of the epoxy-repaired rock sample.

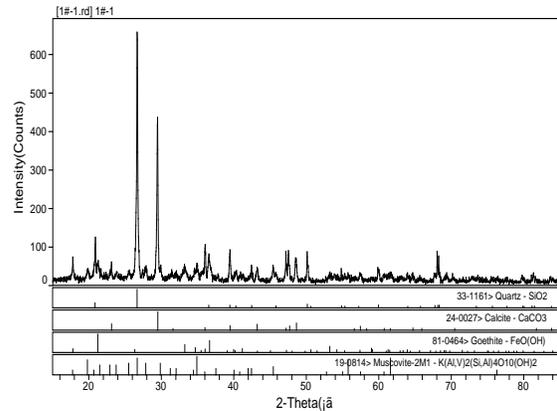
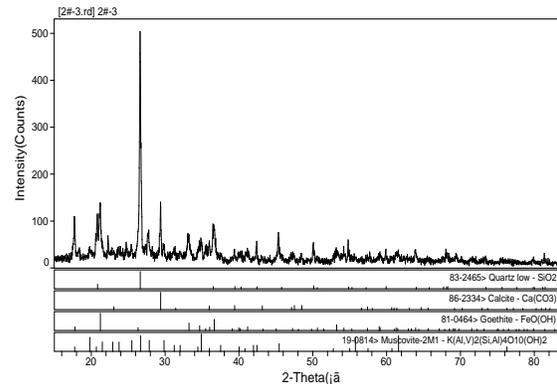
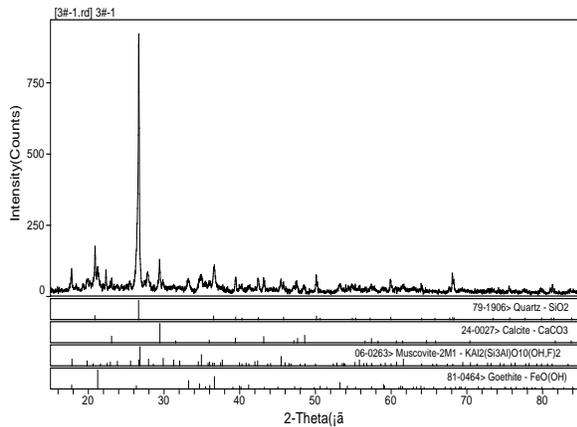
Fig. 7: X-ray diffraction analysis results: (a) weak weathered greenschist; (b) strong weathered greenschist; (c) carbonaceous greenschist

Mineral compositions: Several test for mineral compositions of epoxy-repaired rock by X-ray diffraction method are carried out. Figure 7 shows the X-ray diffraction analysis results for mineral proportions of epoxy-repaired rock.

As shown in Fig. 7, there is an obvious difference between each mineral particle, so that the mineral proportions of epoxy-repaired rock can be determined by XRD method. Table 2 shows the mineral compositions of the epoxy-repaired rocks.

As shown in Table 2, the proportion of SiO_2 is the largest one of mineral, about 40%-50%. The proportion of epoxy resins is about 3.5%-5.5%, compared with Table 1, after chemical grouting, the cracks and voids in the fractured rock are partly repaired. Some smaller cracks and voids can not be filled by epoxy resin particles.

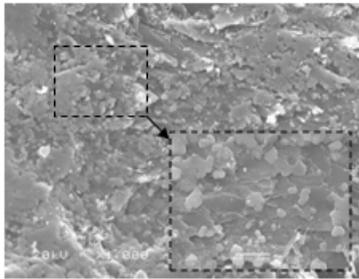
Fig. 8: Microstructural characteristics of the epoxy-repaired rock

Microstructural characteristics: The micro structural characteristics of epoxy-repaired rock are analysis by the SEM method. Figure 8 shows the typical micro structural characteristics of the epoxy-repaired rock.

As shown in Fig. 8, there is lots of epoxy resin particles existed at the crack surface, showing a discrete distribution and can not connect with each other. That mean the filling of epoxy resin in the cracks and voids is partly.

Fractured rock can be repaired by chemical grouting of epoxy resins, how to determine the improvement of epoxy resin for fractured rock is very important. In this study, XRD and SEM methods are adopted to make certain the chemical grouting effect on rocks. Test results show that, the cracks and voids in rock are partly filled by epoxy resins; the proportion of epoxy resin in rock is about 4.5%.
