Research Article

Rock Mass Assessment using Geological Strength Index (GSI) along the Ranau-Tambunan Road, Sabah, Malaysia

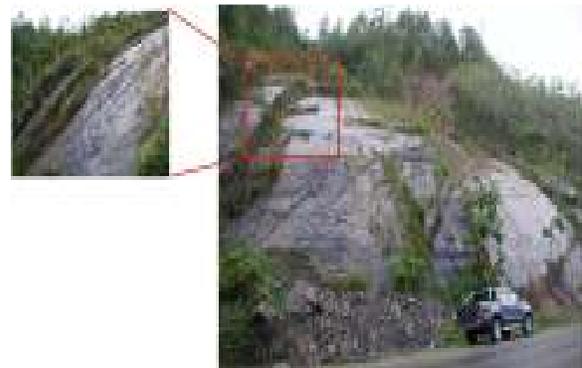
Fig. 4: Rockslide causes by out-dipping of joint planes at station B20

Based on the slope inspection, there are two to three joint sets that are visible for all slopes. Based on field observations, bedding and fold structures are one of the main causes of rockslides due to their “daylighting” planes from the slope (Fig. 4). All of these rock slopes

either have failed completely, failed on some parts of the slopes or show potential for failure. Station B20 for example shows a moderately fresh rock but due to the nature of its daylighting discontinuities, rockfall is observed at the foot slope of this station.
