Finite Element and Experimental Analysis and Evaluation of Static and Dynamic Responses of Oblique Pre-stressed Concrete Box Girder Bridge

Abstract: Hashuang bridge is type of prestressed concrete box girder oblique bridge and it is located in Harbin City within Heilongjiang province in the east north of China. The objectives of this study are to investigate the appearance of the bridge structure and identify all the damages in the bridge structural members and to evaluate the structural performance of the bridge structure under dead and live loads. Finite element analysis is used to analyze the static designed internal forces and dynamic responses by adopting SAP200 software Ver. 14.2.0. Static and dynamic load test are adopted to evaluate the structural performance of the bridge structure. The results of field investigation process of the bridge appearance show that the bridge suffers from serious damages. The web of box girder of the second span near pier No.2 (in the quarter of middle span at 39m on the bridge length) suffers from serious shear cracks. The state of abutments, piers and sidewalks is good, but the bearing, drainage holes, steel rail and expansion joints are not

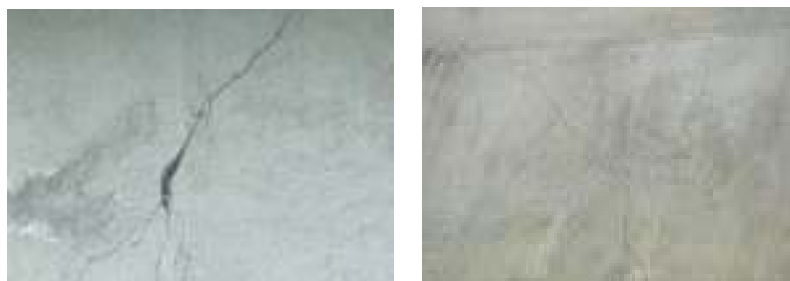
Fig. 2: The cracks in the box girders; (a) outside of box girder, (b) inside of box girder

Field investigation process is done on the structural members of the bridge structure such as all spans of outside and inside of box girders, piers, abutments, bearings, sidewalks and steel rail. The results of investigation process show that the web of box girder of the second span near pier No.2 (in the quarter of middle span at 39 m on the bridge length) suffers from serious shear cracks. The distance between cracked area and the mid-pier No. 2 is about 10.5 m. These cracks extend from the top to lower flange of box girder. There are two cracks incline 45° to the mid-span direction with widths are 0.5 to 2.0 mm and the widest cracks are found in the middle of web of box girder. Both of the outside web and inside web of box girders have the same crack position. The cracks degree of the box girder's outside web is more serious than the inside web. There are six transverse bending cracks on the bottom of box girder around quartile of middle span. The spacing between these cracks range from 20 cm to 30cm and the width is 0.35 mm. In the span No. 3 near the pier, the web of box girder appears 12 diagonal cracks have width range from 0.1 mm to 0.12 mm. Figure 2 shows the cracks in the box girders. From this figure, it can be noted that the state of the bridge structure is not good because there are serious cracks have large width.

- According to the results of damage investigation process, finite element analysis, static load test and dynamic load test, the main problem of the bridge structure in the original design of prestressed tendons. Therefore, this study recommends for repairing and strengthening the bridge structure to increase the stiffness and strength and to improve the bearing capacity of the bridge structural members to increase the service life of the bridge structure.

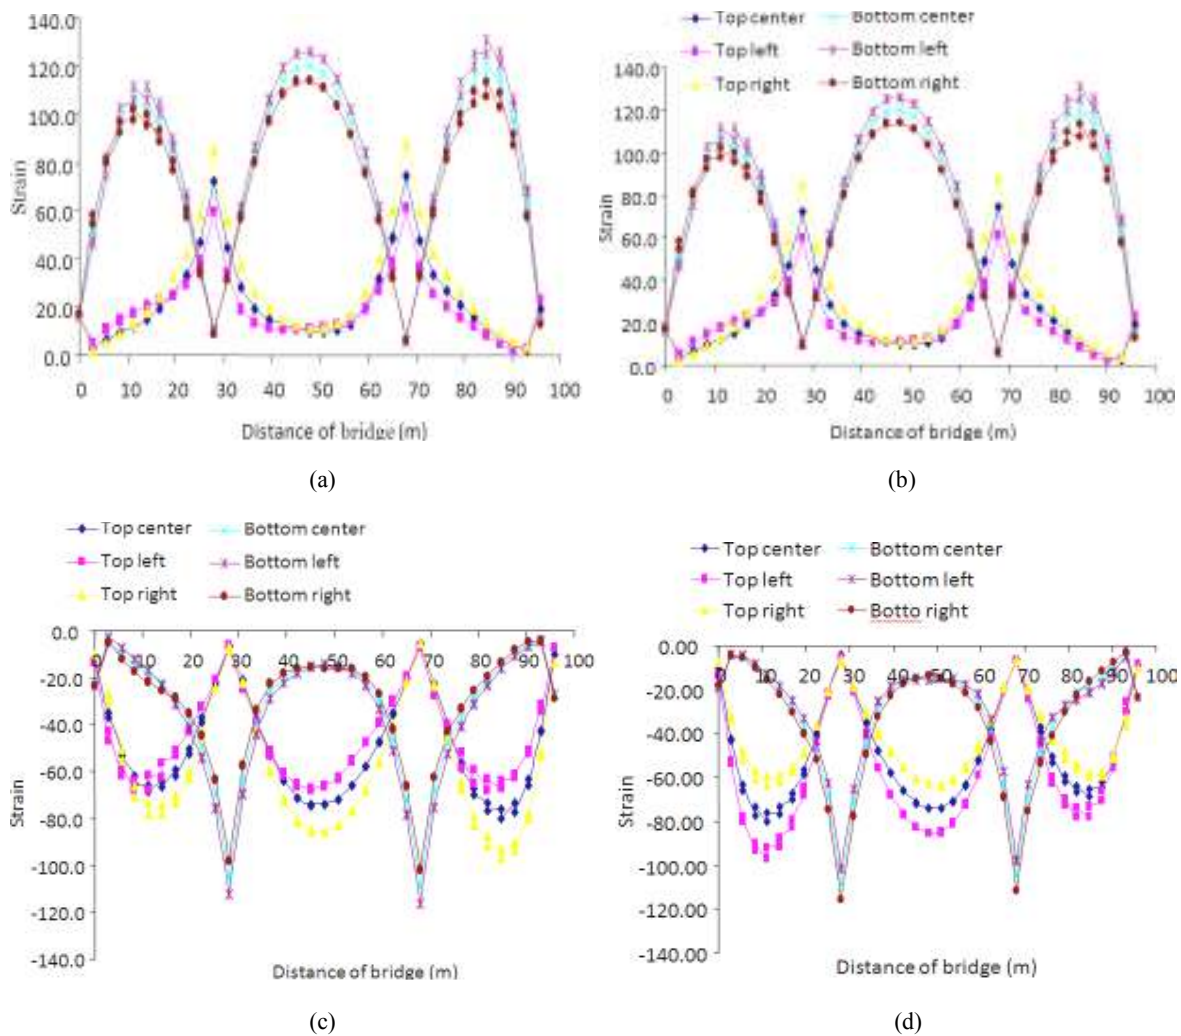
- **Analysis of concrete strain:** Figure 6 shows the distribution of strain along the bridge length. From this figure it can be noted that the maximum positive values of strain for object 1 and object 2 are equal to 131 $\mu\epsilon$ and 127.69 $\mu\epsilon$ which locates in the bottom left and bottom right of box girder at distances 85 and 11 m of the bridge length respectively. For negative values of strain, the maximum value of strain of object 1 and

Fig. 6: The values of strain under live load; (a) Positive values of object 1; (b) Positive values of object 2; (c) Negative values of object 1; (d) Negative values of object 2

object 2 is equal to -116.4 and $-116.06\mu\epsilon$ which occurs in the bottom left of pier box girder (pier No.2) and bottom center of pier box girder (pier No.2).

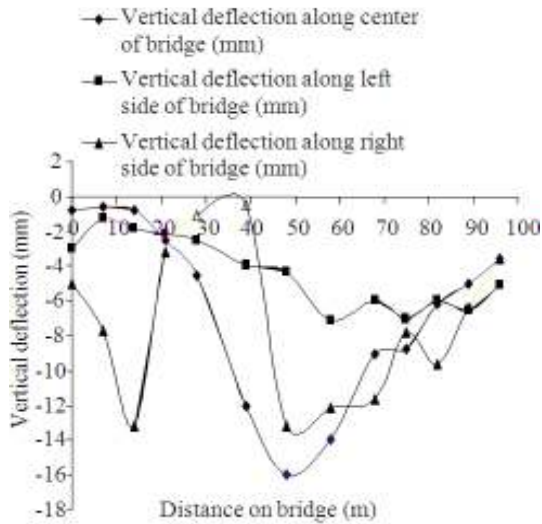
- Analysis of vertical deflection:** The analysis results of vertical deflection due to static live load shows that the maximum downward vertical deflection is equal to -16mm which occurs in the center of the bridge structure at distance 48m . Figure 7 shows the vertical deflection due to static live load. This value is less than the allowable limit value which is equal to 66.6mm . Therefore, the value meets the requirement:

Fig. 7: The vertical deflection due to static live load

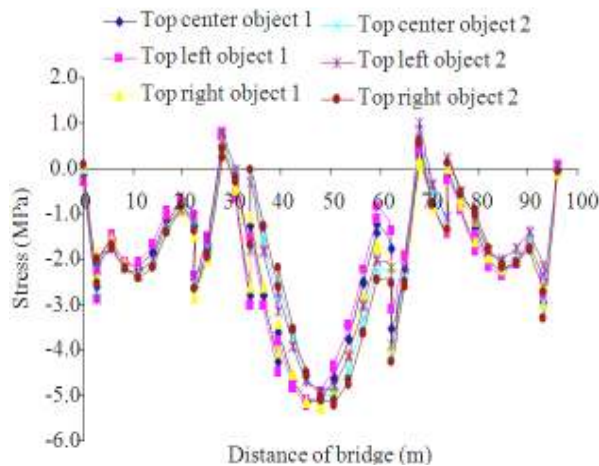
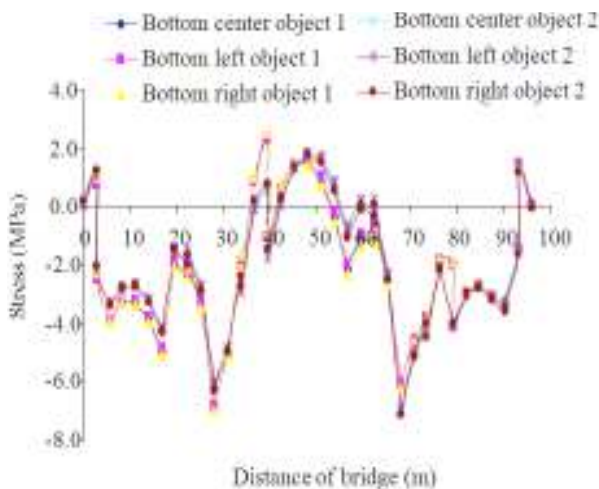
- Analysis of stress:** Figure 8 shows the distribution of stresses along the bridge length. For top of box girders, the maximum compressive stress occurs in the top right of box girder in the center of middle span at distance 48m of object 1 which is equal to -5.3MPa and is less than the allowable limit value in Chinese codes (JTJ023-85, 1985; JTG D62-04, 2004) which are equal to -19.6 and -18.78MPa . The tensile stress is appeared in the top left of pier box girder at distance 68m of object 2 and the maximum value of tensile stress is equal to 1MPa which is less than the allowable limit values in codes. For bottom box girder, the maximum compressive stress is equal to -7.2MPa which occurs in the bottom right of pier box girder at distance 68m of object 2 and it is less than the value allowable limit in Codes (-19.6 and -18.78MPa). The maximum value of tensile stress is

Fig. 8: The distribution of stresses along the bridge length; (a) Top of box girder, (b) bottom of box girder

equal to 2.5 Mpa which is located in the quarter of middle span at bottom right of box girder at 39m of object 1. This value is less than the value in Code-JTJ023-85 (2.99 MPa), but it is more than the value in the Code-JTG D62-04 (1.68MPa). Also there are tensile stress values are appeared in the bottom left of box girder at distance 39 m of object 2, bottom right of box girder in the center of middle span at distance 48 m, bottom center of box girder in the at distance 39 m of object 1 and bottom left of box girder at distance 39 m of object 1, these values are 1.8, 2.4 and 2.3 MPa, respectively. Therefore, the cracks will be appeared in these locations of the bridge structure.

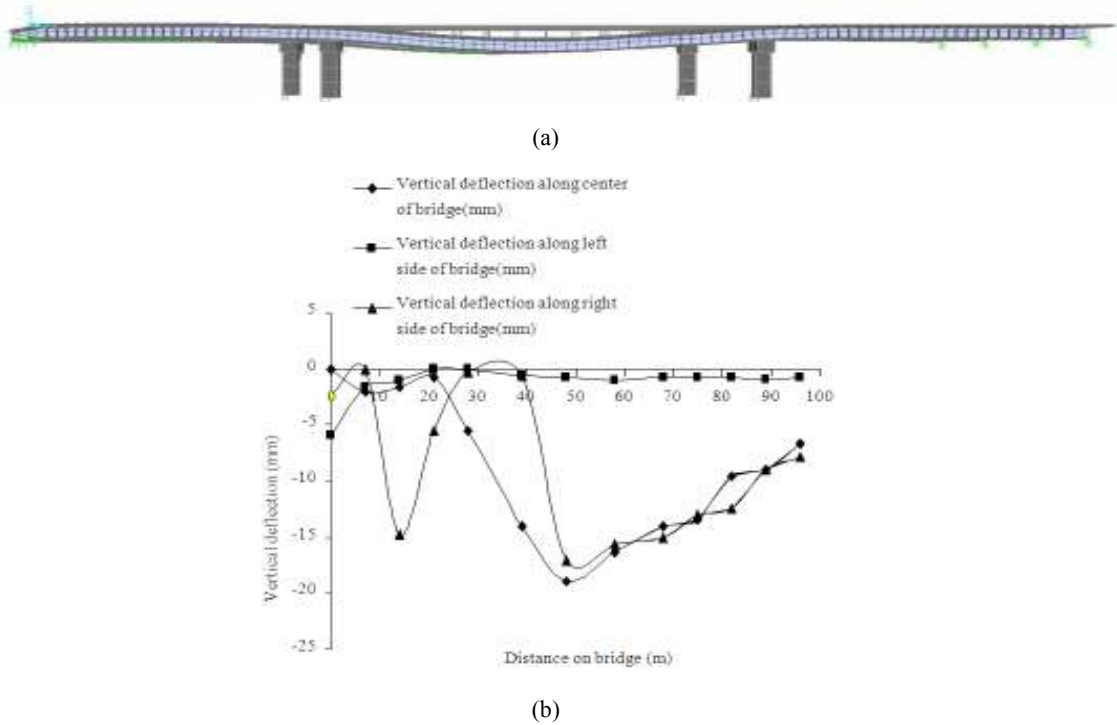
- **Analysis of vertical deflection:** The distribution of vertical deflection due to load combination I is shown in Fig. 9. From this figure it can be seen that the maximum value of downward deflection is equal to -19 mm in the right side of middle span center (center of bridge).

Fig. 9: The vertical deflection due to static live load; (a) elevation view, (b) transverse view, (c) vertical deflection curve

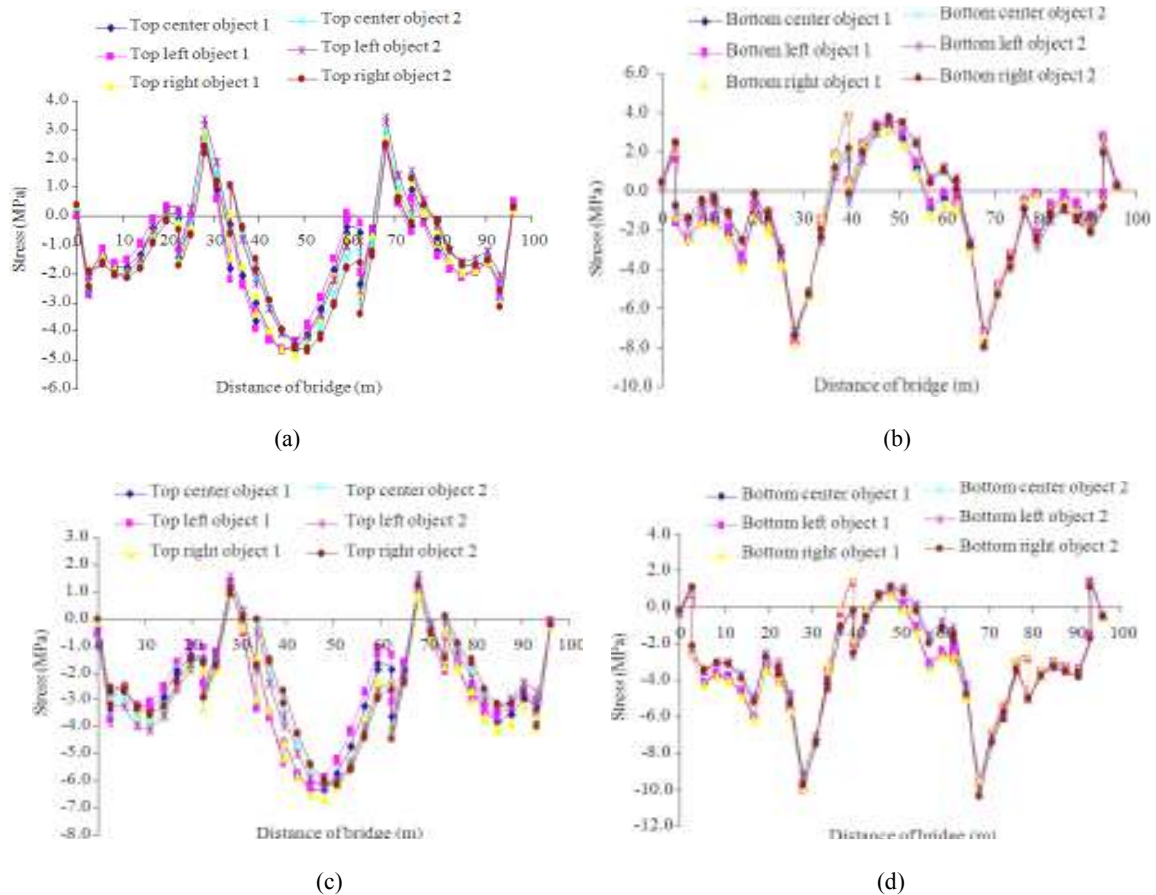
- **Analysis of stress:** The analysis results of stresses are shown in Fig. 10. For maximum top stresses of box girder, the maximum value of compressive stress occurs in top right of box girder in the center of middle span at distance 48m of object 1 which is equal to -4.8MPa and it is less than the allowable limit values in the Codes (-14 and -13.4 MPa). Tensile stresses are appeared in the tope pier box girder which ranges from 2.5 to 3.4 MPa and these values are more than the allowable value in Code-JTJ023-85 (2.34 MPa) and Code-JTG D62-04 (1.68 MPa). Therefore, the cracks will be appeared in these locations of the bridge. For maximum bottom stresses of box girders, the maximum value of compressive stress is equal to -8 MPa which locates bottom right of pier box girder at distance 68 m of object 2 and it is less than the allowable values in the Codes (14 and 13.4 MPa). Tensile stresses are appeared in the bottom of box girders and the maximum value is equal to 3.8 Mpa which is located in the quarter of middle span at bottom right of box girder at 39m of object 1. This value is more than the allowable limit value in Code-JTJ023-85 (2.34 MPa) and Code-JTG D62-04

Fig. 10: The distribution of stresses along the bridge length; (a) maximum top stresses, (b) maximum bottom stresses, (c) minimum top stresses, (d) minimum bottom stresses

(1.68 MPa). Therefore, the cracks will be appeared in this location of the bridge. For minimum top stresses, the maximum value of compressive stress occurs in top right of box girder in the center of middle span at distance 48 m of object 1 which is equal to -6.7 MPa and it is less than the allowable limit values in the Codes (-14 and -13.4MPa). There are tensile stresses in the tops box girders. The maximum value is equal to 1.6 MPa which locates in the top left of pier box girder (pier No. 1 and No.2) at distance 28 and 68 m of object 2. This value is less than the allowable limit values in Code-JTJ023-85 (2.34 MPa) and Code-JTG D62-04 (1.68 MPa). For minimum bottom stresses, the maximum value of compressive stress is equal to -10.4 MPa which locates in the bottom right of pier box girder at distance 68 m of object 2 and it is less than the values in the Codes (-14 and -13.4MPa). The maximum value of tensile stress is equal to 1.6 MPa which occurs in the bottom right of box girder at distance 48 m of object 1. This value is less than

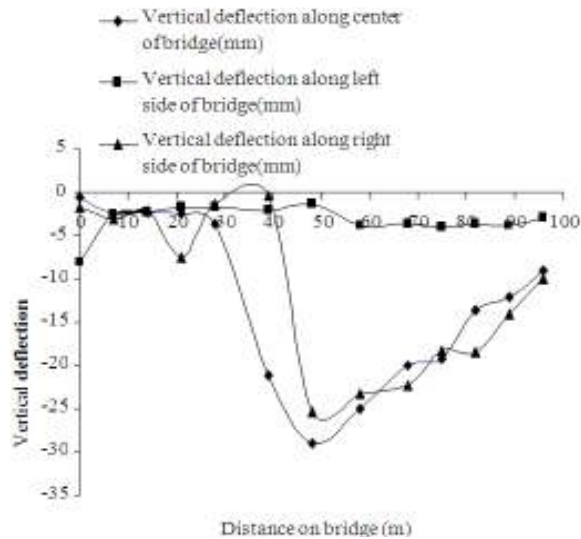
Fig. 11: The vertical deflection due to load combination II; (a) vertical deflection curve, (b) distribution of vertical deflection on longitudinal bridge model

- **Analysis of vertical deflection:** The results of vertical deflection of load combination II are shown in Fig. 11. The maximum value of vertical deflection is equal to -29 mm which is located in the center side of the middle span center of the bridge.

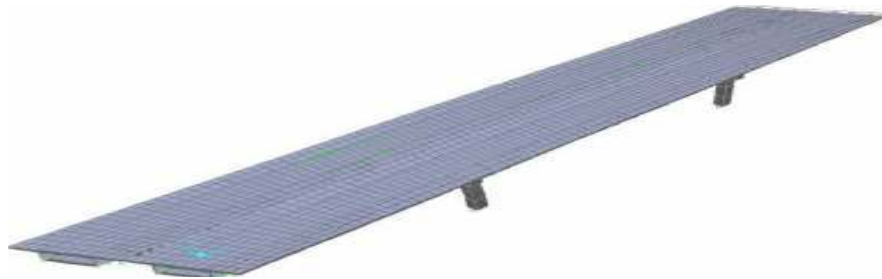
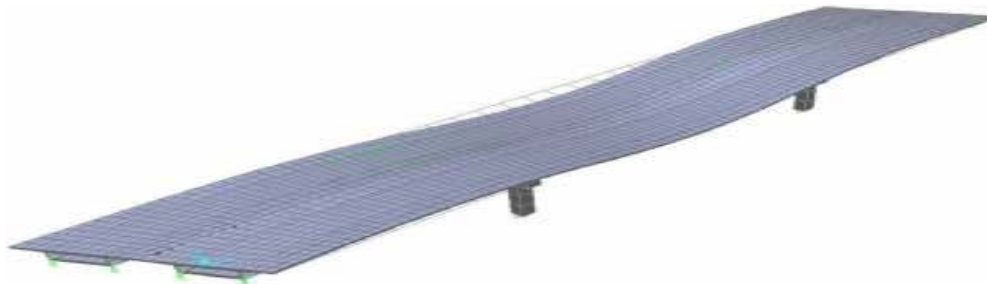
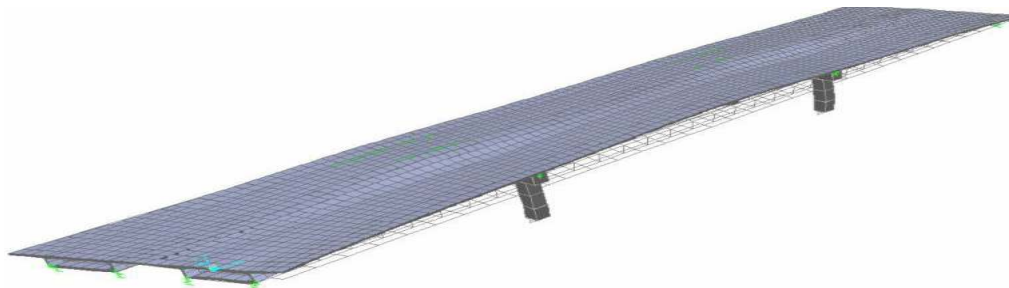
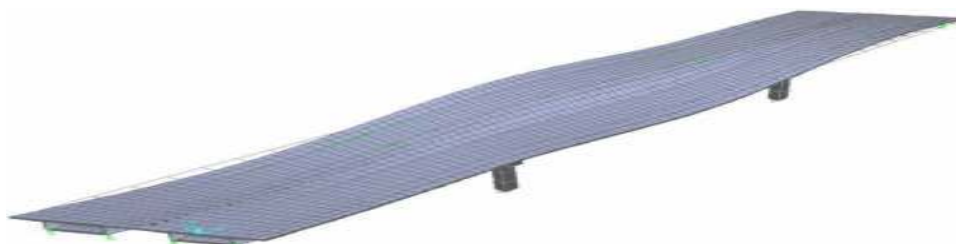
Table 2 lists the values of natural frequency for modal modes. Figure 13 shows the first five modes of the bridge structures. According to deflection shape of modal mode No.3, the natural frequency of the bridge structure is equal to 4.9635 Hz. According to Table 3, the impact factor ($1+\mu$) of the bridge structure is equal to 1.266.

Fig. 13: The mode shapes of modal; (a) Mode No. 1; (b) Mode No. 2; (c) Mode No. 3; (d) Mode No. 4; (e) Mode No. 5

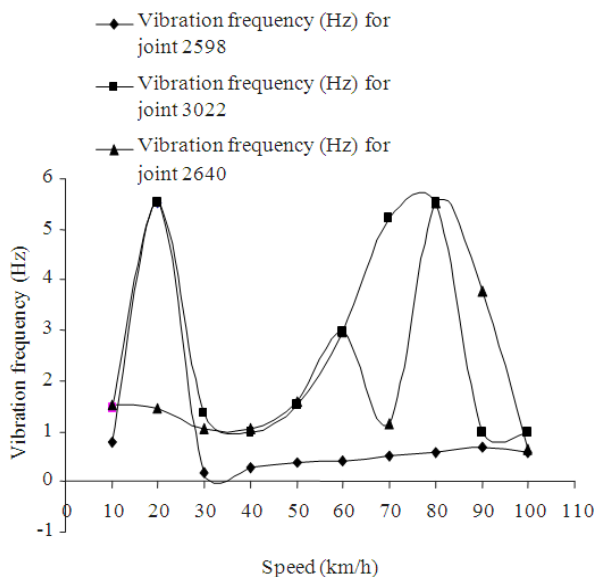
Fig. 14: The values of vibration frequency for joint 2598, joint 3022 and joint 2640

The front axles have 60 kN and the two rear axles have 240 kN, each one has 120 kN. Figure 14 shows the relationship between vehicle speeds and vibration frequency. The average values of vibration frequency for joint No. 2598, No.3022 and No.2640 is equal to 1, 2.65 and 2.08Hz, respectively. Therefore, the average value of vibration frequency of the bridge structure is equal to 1.91 Hz which is less than the natural frequency 4.963 Hz, indicating that the vibration state of the bridge structure in good state. According to Table 3 and vibration frequency, the impact factor of the bridge structure can be calculated. Figure 15 shows the values of impact factor under different speeds. From this figure it can be noted that the most values for the selected joints are near for each others and the maximum value of impact factor is equal to 1.286 which occurs under speeds 20km/h and 80km/h. the average value of impact factor of the bridge structure is equal to 1.104 which is less than the value from natural frequency 1.266, indicating that the vibration state of the bridge structure is good.

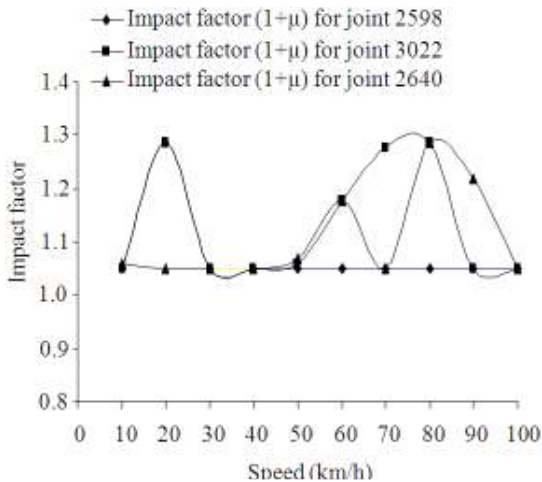
Fig. 15: The values of impact factor under different speeds

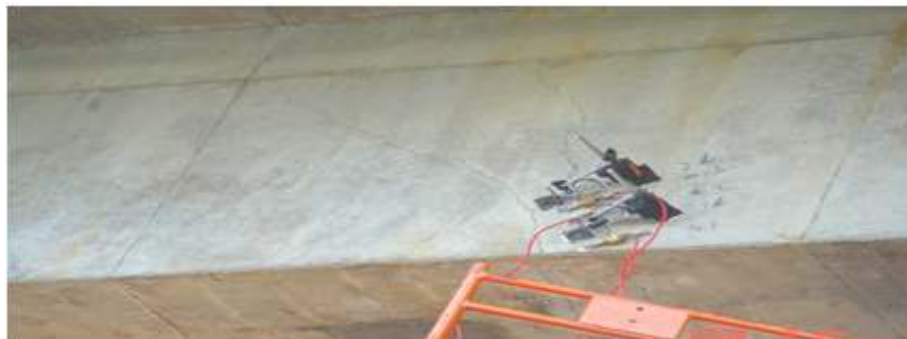
Fig. 18: The transverse arrangement of deflection measuring points

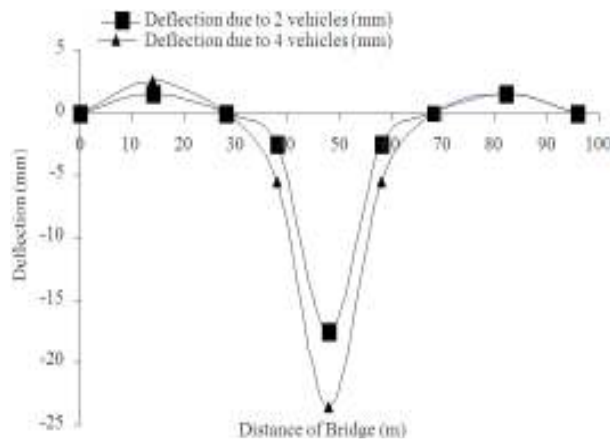
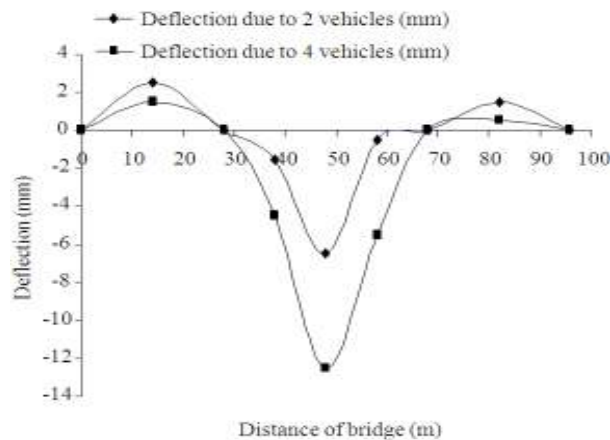
Fig. 19: The deflection values; (a) Measuring point 1; (b) Measuring point 2

- **Vertical deflection results:** Figure 19 shows the deflection of measuring points 1 and 2. From this Figure it can be noted that the maximum downward deflection is equal to -23.5 mm which locates within half of middle span No.2 under 4 vehicles loads in the measuring point No. 1 and it is less than the allowable limit value which is equal to 66.6m.

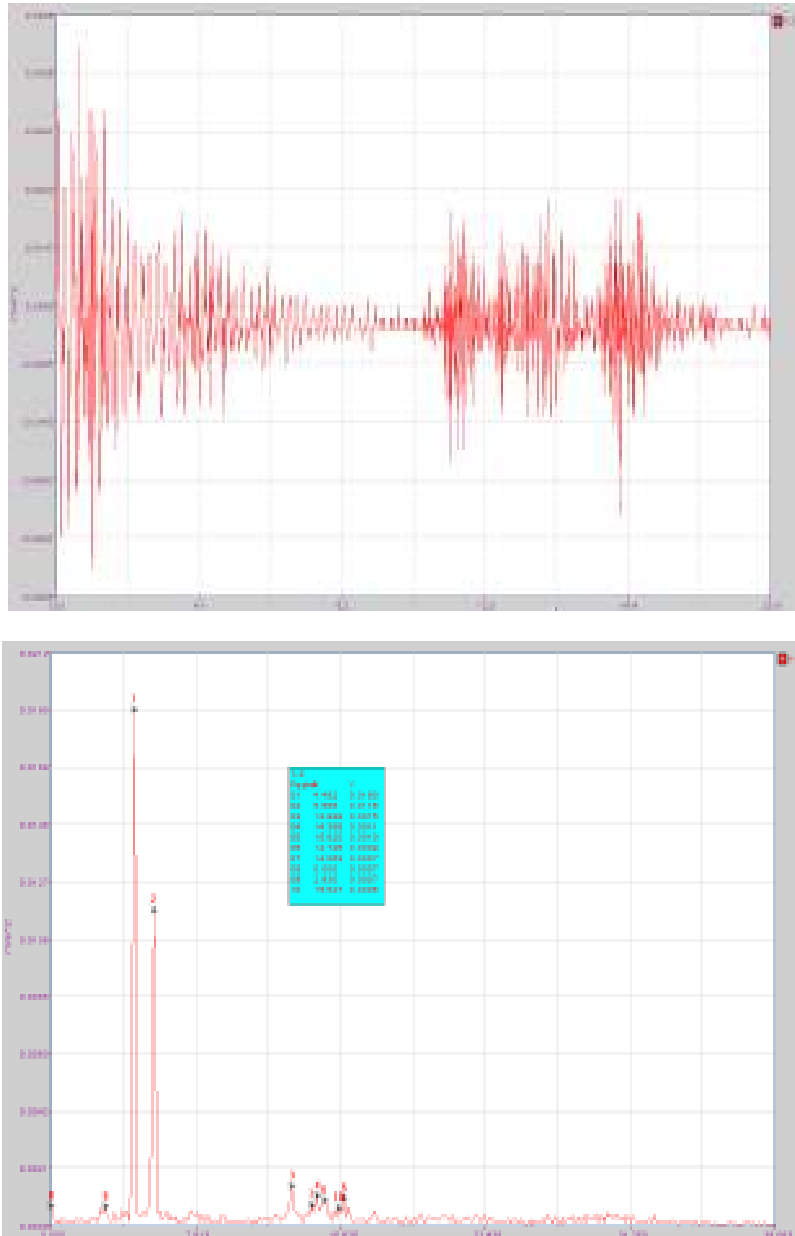
Natural and vibration frequency: Figure 20 shows the spectral analysis curve of natural frequency and dynamic acceleration of mid-span No.2 when the bridge is opened to traffic load. From this figure it can be seen that the values of measured natural frequency is equal to 4.482 Hz. The vibration frequency of bridge structure is equal to 5 Hz which is close to the natural frequency 4.482 Hz of the structure. So under the action of vehicles loads, bridge can easily cause a resonant phenomenon, resulting in dynamic acceleration, dynamic strain and dynamic displacement by a big

Fig. 20: The spectral analysis curve of natural frequency and dynamic acceleration of mid-span No. 2

The value of measured natural frequency is equal to 4.40 Hz which is less than the theoretical natural frequency which is equal to 4.963 Hz. The value of dynamic load test coefficient is equal to 0.88 which is within the fourth level that represents the very poor state, indicating that the bridge structure suffers from long time vibration because of the connection between the two sides of box girders (forward and backward direction) is not good. Therefore, the measured vibration frequency under passing the vehicles on the bridge is equal to 5 Hz which is more than the measured natural frequency which is equal to 4.482 Hz. Therefore, to reduce the vibration of the bridge structure, the connection between two sides of the bridge must be strengthened by adopting cross beams to increase the rigidity of the connection areas.
