Fragile Landscape: Impact and Consequences of May 2014 Flash-flood Disaster in the Aqaba Area, Southern Jordan

Yahya Farhan and Ali Anbar

Department of Geography, The University of Jordan, Amman, Jordan

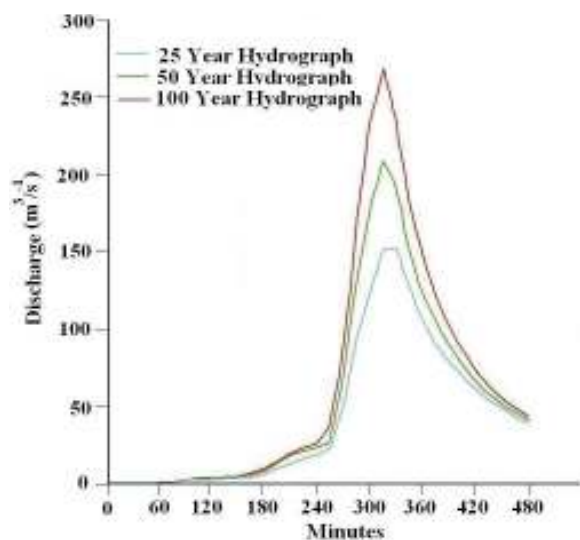
Fig. 6: Predicted maximum discharge (25, 50 and 100 year return periods, respectively) for Wadi Mubarak (1991 flood)

discharge for flash-floods of a 25 year return period was 135.3 m³/sec (Fig. 6), for 50 year return period was 210 m³/sec and for 100 year return period was 269.2 m³/sec (Jordan Consulting Engineer Co., 1993). The sudden rise in peak discharge is occasionally influenced by the blockage of culverts installed along channel crossing of the Aqaba back road and the mid-road by debris materials in the upper reaches of the wadis, thus accelerating runoff, roads and property damages. Field observations indicated that the maximum intensity of the flash-floods occurred in the upper and middle reaches of the wadis, while maximum inundation and standing water after rain were achieved at the lower reaches and toes of alluvial fans. Located here are most of the residential areas, the airport, container port, public beach, green areas and large yards and light industry area. Considering the predicted maximum discharge related to wadis crossing the piedmont zone (Wadi 2 to 14) and the bajada (W. Mubarak until W. Yutum to the north), most hazardous catchments are: Wadi 2; Wadi 7; Wadi 9; W. Mubarak; W. Jeishieh; W. Shallalah; W. Shahbi and W. Yutum (Aqaba Region

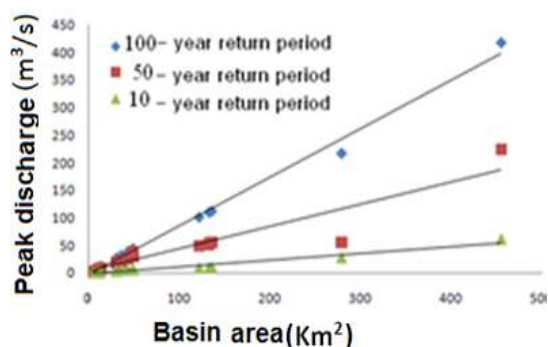
Fig. 7: Relation between the basin area and unit peak discharge for different wadis of the piedmont zone

Authority, 1987; Jordan Consulting Engineer Co., 1993; Central Water Authority, 1966). Plotting the predicted UH peak discharge of flash-floods pertained to the main wadis of the Aqaba area, against catchment areas (km²) (Fig. 7) for different return periods (25, 50, 100 year return period, respectively), illustrates that the Aqaba area is seriously threatened by flooding water and sediments discharge. Moreover, in case of flash-floods of different magnitudes, there is no sufficient time to evacuate residents of Aqaba, or to apply precautionary safety procedures. Thus, comprehensive and efficient flood protection measures are urgently needed.

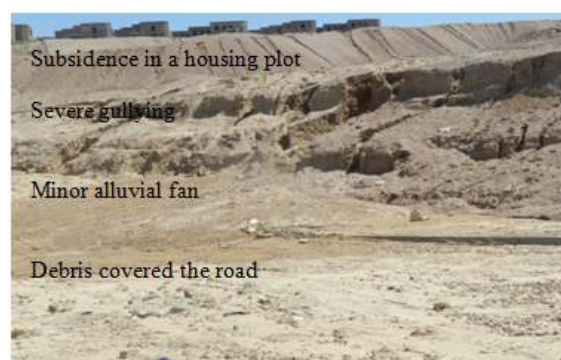
Fig. 12: Minor alluvial fan, severe gullying, road covered with debris and subsidence of a housing plot

Sections of these roads were affected by the flood. Continuous leveling of the piedmont surface in several sites (between the coastal highway and the mid-road) to prepare appropriate sites for building construction, maximize sediment supply and gully development (Fig. 10) during flooding. However, wadi systems developed on granite with long alluvial fans and man-made areas are the most critical terrain units for flooding and resultant engineering problems. Most of the problems recognized on the mid-road, secondary road network, leveled surfaces with steep-side slopes and spoil heaps are found on these units. Sediment sources, rill and gully erosion, slumping, mud and debris flows and subsidence are characteristics of the piedmont terrain zone. In several sites, on the coastal highway, mid-road and other roads network, slumped materials and debris overrode the road surfaces (Fig. 11). Mini alluvial fans were initiated and covered the road surfaces (Fig. 4c and 12). Uplifted corals in several areas were also exposed by gully erosion.
